re:news

Vol. 2, No. 1

March 2004

- *Masonry Restoration*
- *Moisture Issues*
- *Stabilization & Support*
- *DIS Project Profiles*

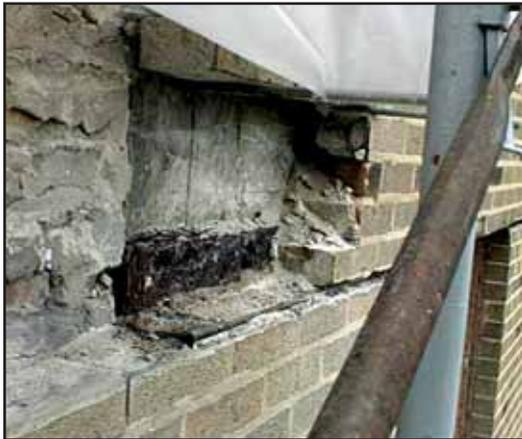
Masonry wall construction typically includes a number of common elements; structural "back-up", steel support angles, flashing and weeps, and face brick. In years past, the importance of flashing and weeps were under emphasized. In many instances, this has led to rusting of structural steel elements within the wall. As the steel turns to rust it not only loses its capacity to carry loads, but the rust expands and forces unintended movement of the wall. Prior to failure of the steel, the wall shifts; this shifting breaks the brick's ties to the back-up and creates cracking of mortar joints and brick.

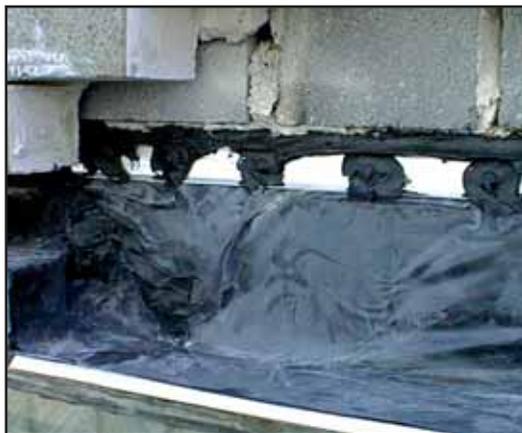
Prior to beginning any work, the masonry above the steel must be stabilized and supported, (see Structural Elements in this issue). With supports in place, the existing angle is replaced, the new steel is primed and painted then bolted into place. Flashing is placed over the angle so that any water entering the wall system will be directed out. The new brick placed on this flashing will have weeps placed at the flashing to allow trapped moisture to flow freely out of the wall cavity.

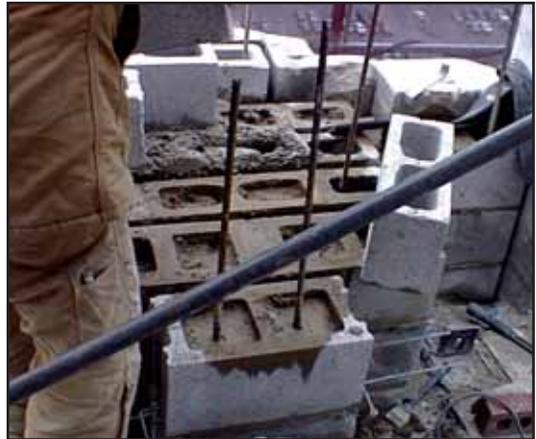
In some cases water infiltration has caused damage to the structural back-up itself. In a case like this, the face brick has to be removed entirely, and then the back-up must be removed and rebuilt. In a masonry structure, one common construction method is to use concrete block. If the structure is to be significantly higher than it is wide, the block needs to be reinforced. The cells of the block are filled with structural strength grout and steel reinforcing bars. Once the structure has achieved its design strength, face brick can be built around it and fastened to it.

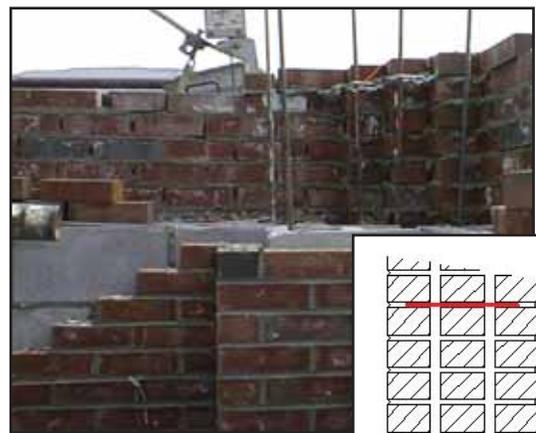
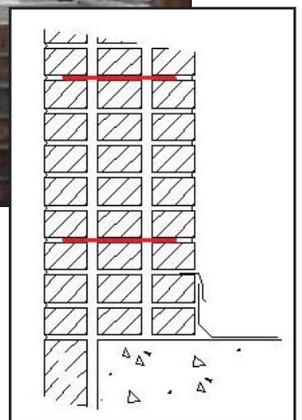
These walls also incorporate horizontal reinforcing within the mortar joints; this reinforcing is often referred to as ladder ties. The face brick is built around steel straps incorporated into the mortar joints. This strapping is one way of tying the face brick to the back-up masonry.

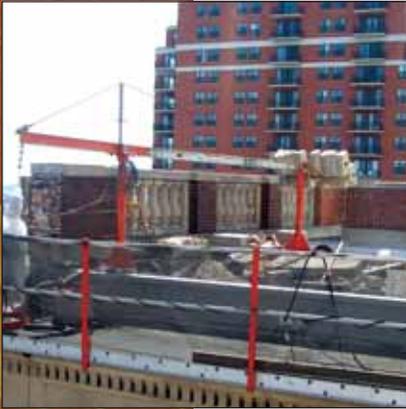
■ Hotel, Michigan Ave., Chicago, Illinois

The stone and masonry façade of this significant Michigan Avenue hotel requires continuous maintenance along with rebuilding of distressed areas. Parapet wall dismantlement and reconstruction on this south loop gem sometimes includes substantial structural refurbishment to assure decades of stability. Steel beams and concrete repairs are completed seamlessly with major masonry rebuilding. All precision work is coordinated in house and completed by the craftsman of Design Installation Systems.

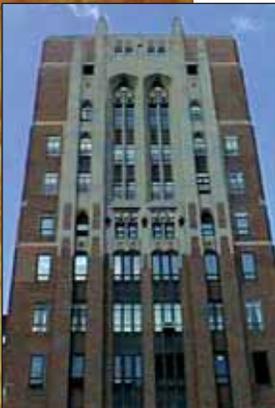
■ UIC - School of Medicine, Chicago, Illinois

This project consisted of completely dismantling and rebuilding the ten foot high limestone and masonry parapet walls at this historic university building. As all of the decorative limestone was salvaged and reused to preserve the architectural integrity of the building, extensive surveys were performed and documented. The engineered rigging required to accommodate the height of the parapet walls and the extraordinary weight of the limestone piers added to the complexity of the project. Custom trolley systems, beams and hoists were used by the craftsmen to facilitate the movement of the large, decorative stones.

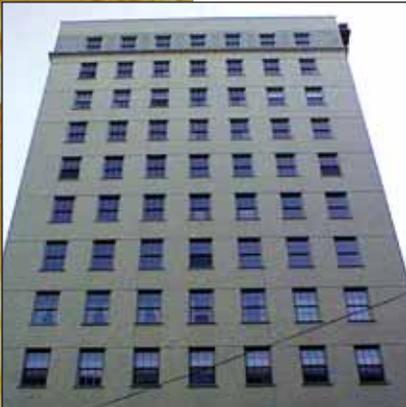
■ 233 East Walton, Chicago, Illinois

Located in the shadow of the John Hancock building, this 15 story landmark needed total removal and rebuilding of the north and east masonry facades. Unlike most projects of this nature, DIS decided to complete the work from swing stage scaffolds. Using this type of equipment eliminated the need, and the cost, of encasing the two sides of the building in scaffolding built up from the ground. This innovative technique reduced disruption to the building owners, minimized landscaping damage and allowed for greater flexibility in access to work areas. The completed project is a testament to the thoughtful planning and careful execution of the work.

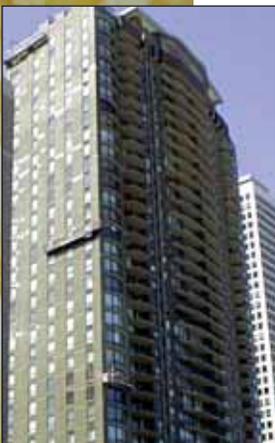
■ The Carlyle, Chicago, Illinois

This prominent Lake Shore Drive hi-rise was in need of maintenance to stave off the adverse effects of being located on the lake shore. Wind and rain had eroded a significant number of mortar joints, in some cases this lead to water infiltration. Design Installation Systems was asked to help locate and repair water damaged steel within the wall and to replace broken and deteriorated brick in the façade. Once repairs were completed, tuck pointing and sealant work returned the masonry to its intended water tight condition.

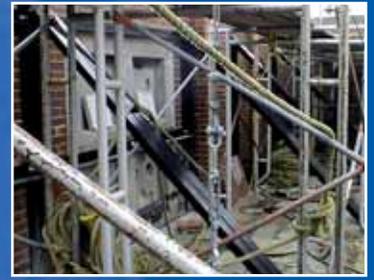
The black steel supports shown are angle frames custom built by DIS. These frames were fastened to the interior of the ten foot high, composite parapet wall for stabilization during demolition.

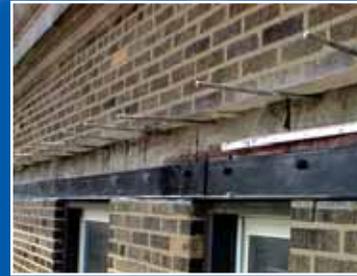
One common method for supporting brick is to install stainless steel rods

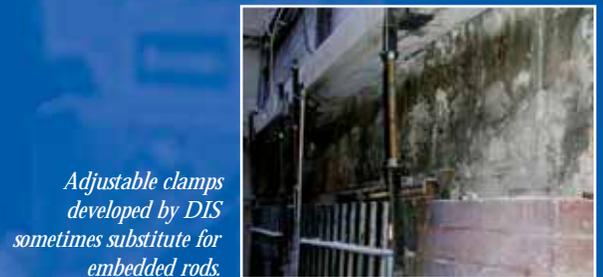
Adjustable clamps developed by DIS sometimes substitute for embedded rods.

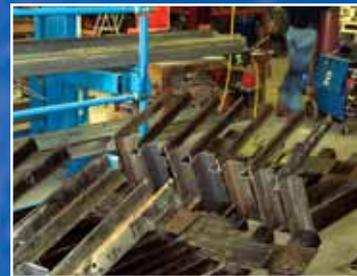
Fabrication of custom fitted cornice supports. All work completed at Design Installation Systems' shop.

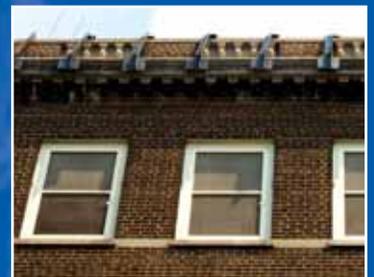
Cornice supports place on the building to stabilize the cantilevered stones. These will remain in place until the parapet wall can be rebuilt.

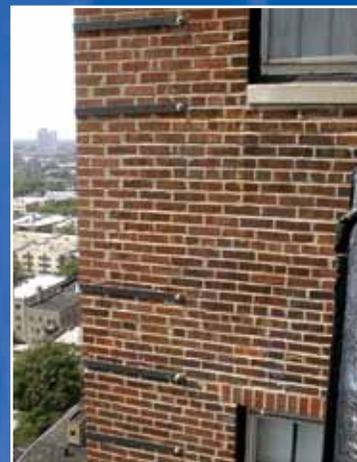
Masonry corners are particularly susceptible to instability when a wall is in distress. Steel straps are used to keep the corner in place until demolition can begin.
